Sustainable interventions: Rehabilitation of old timber structures with traditional materials

Tiago Ilharco

Faculty of Engineering of Porto University

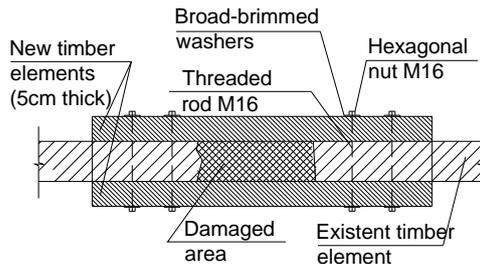
Fig. 1 – Strengthening of the damaged structural elements with timber pieces.

This operation consisted in the fixation of new timber pieces on both sides of the damaged structural elements, with M16 stainless steel threaded rods with hexagonal nut and broad-brimmed washers (to increase the tension distribution), endowing it of an higher inertia, Fig. 1 and Fig. 2. The new timber pieces had physical and mechanical characteristics similar to the *in situ* elements and were treated against biotic attacks; the steel rods were submitted to a treatment to increase their fire resistance.

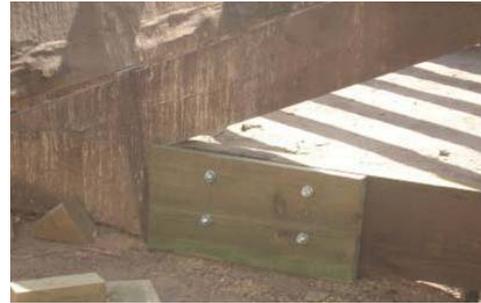
Fig. 2 – Strengthening of a damaged tie beam with timber pieces.

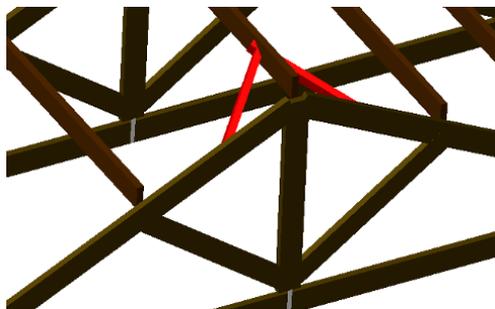
Fig. 3 – Introduction of bracings to reduce the buckling length of the compressed elements (rafters).

The introduction of new timber bracing elements was suggested to reduce the length of the compressed elements (rafters and struts), decreasing the possibility of buckling. These new bracing elements were installed in both sides of the reinforced element and adequately screwed to the battens or to the ridges, Fig. 3 and Fig. 4.

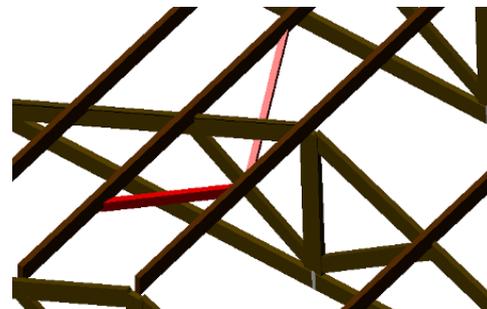
Fig. 4 – Introduction of bracings to reduce the buckling length of the compressed elements (struts).

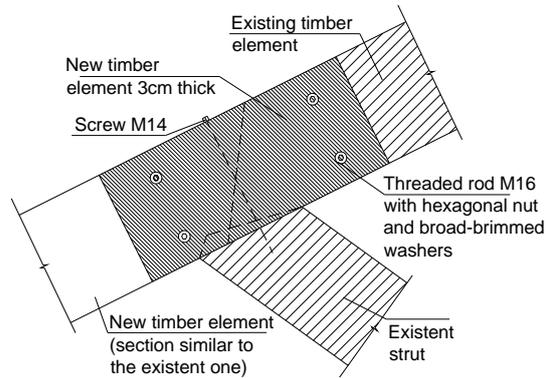
Fig. 5 – Substitution of a part of a structural element.

In certain situations it was necessary to substitute (globally or partially) the damaged elements by new ones. While in the case of the struts and ridges it was considered convenient to substitute the complete length of the element, in the case of rafters and tie-beams it was possible to substitute only a part of it, with the connection between the new and the existent being done with new timber pieces in each side of the elements, fixed with M16 threaded rods and screws, Fig. 5 and Fig. 6.

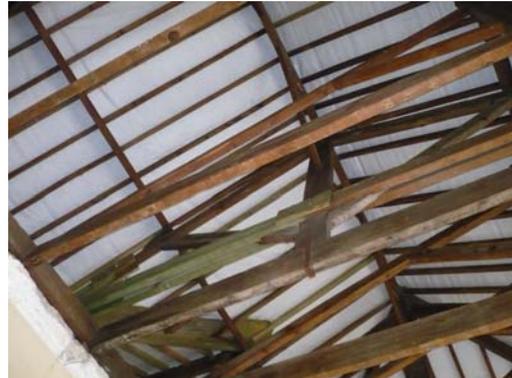
Fig. 6– Substitution of a part of secondary tie beam.

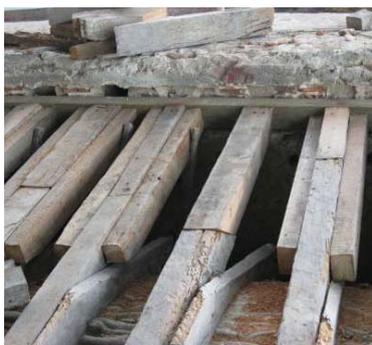
The intervention in Valadares Palace concerned the rehabilitation of the vaulted ceilings, supported by timber beams with a length of approximately 8,0m. After the survey of these beams with the non destructive equipment called Resistograph, it was possible to conclude about the intense degradation of the beams supports due to biotic attacks: insects and fungi. It was also noticed a considerable deflection at the mid-span of the beams (about 20,0cm), caused by the load of a heavy support system of a lamp located at the top of the main stairs (10). Therefore it was recommended a local intervention to rehabilitate the beams supports and a global intervention to correct the beams deformations.

Fig. 7 – Strengthening of the damaged structural elements with timber elements.

The rehabilitation of the timber beams supports was performed through the fixation (with screws), to their sides, of new timber elements. These new elements, made of the same wood species of the *in situ* elements, created the new support of the damaged beams in the walls. Afterwards the new elements were connected to a mudsill installed at the top of the wall, to guarantee the global behaviour of the building and their correct connection to the stone masonry wall, Fig. 7 and Fig. 8. The damaged extremities of the beams were cut and the remaining wood was treated against biotic attacks, Fig. 9.

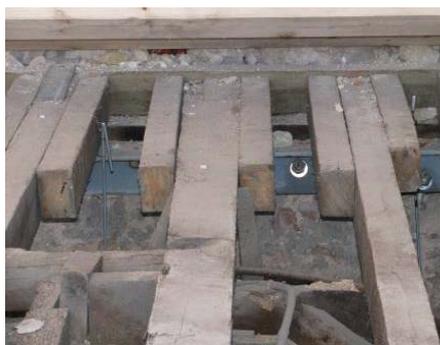
Fig. 8 – Strengthening of the damaged structural elements with timber pieces and a steel bracket.

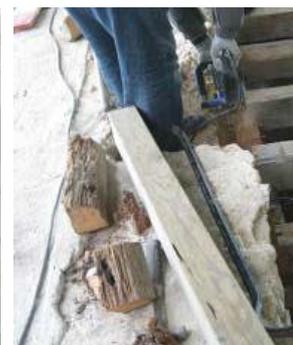
Fig. 9 – Cut of the damaged parts of the beams.

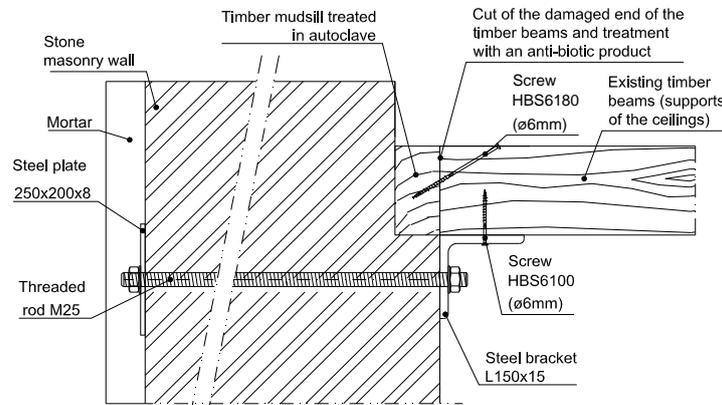
Fig. 10 – Strengthening of the damaged structural elements with timber pieces and a steel bracket.

A metallic bracket (L150x15) was also fixed to the masonry wall through threaded rods (crossing the whole thickness of the wall) to improve the beams supports and to contribute to the wall strengthening, particularly in out of plan actions, in an intervention oriented to the seismic protection of the building, Fig. 10. All the new timber elements were previously treated in autoclave with an anti-biotic product. On the other hand, all the steel elements were submitted to a treatment to increase fire resistance and to

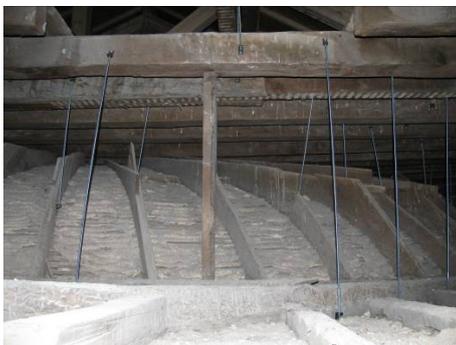
Fig. 11 – Improvement of the ceiling's support with the use of threaded rods.

After the rehabilitation of the supports and the removal of the heavy load of the lamp from the mid-span of the beams, the existing deflection was removed throughout a system of steel cables. Before the restoration of the plasters, the ceiling support was also improved with the use of small threaded rods fixed to the timber beams, Fig. 11 and Fig. 12.

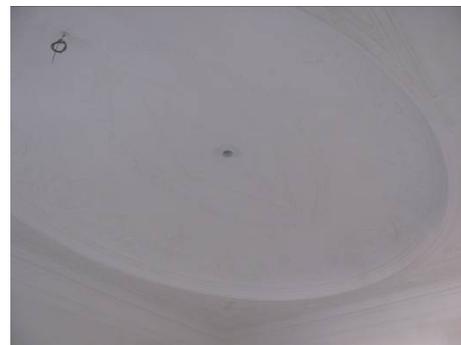
Fig. 12 – Ceiling after the correction of the deformation and restoration of the plaster.

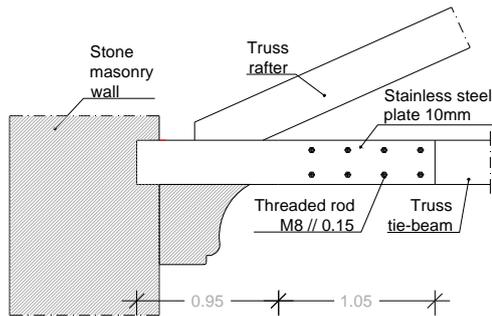
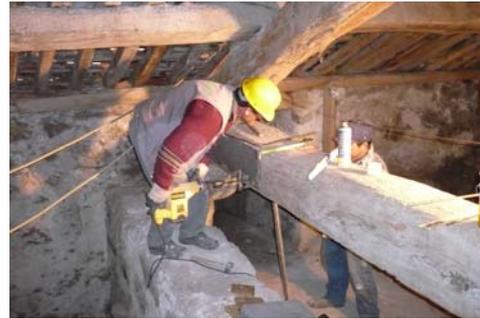
The tests performed with the Resistograph in the timber structural elements of the roof of Valongo Church confirmed the deep degradation of some of the tie beams of the trusses, with losses of the transversal section exceeding, in some cases, 50%. Some other structural problems were also observed in the trusses, namely the fact that some hangers were loading the tie beams, the existence of deficient connections between structural elements, the intense degradation of the rafters and ridges supports in the masonry walls and the deformation of the steel elements that perform the connection between the tie beams and the walls (12). Since the substitution of the roof structure wasn't an option, not only by its patrimonial value, but also because of the technical difficulty and costs associated to an intervention of that type, the solution consisted in localized structural interventions, as it is described in the following points.

Fig. 13 – Strengthening of a support of a tie beam with steel plates and threaded rods.

The supports of the tie-beams were rehabilitated with steel plates, 6mm thick, in both sides of the element, through threaded rods ($\Phi 10\text{mm}$), up to a distance of 1,0m from the wall to guarantee the connection to the sound part of the wood, Fig. 13. The steel plates were introduced in existent openings at the masonry walls, the damaged parts of the wood were removed and the sound parts were treated against biotic attacks and separated from the sealing material with a lead sheet.

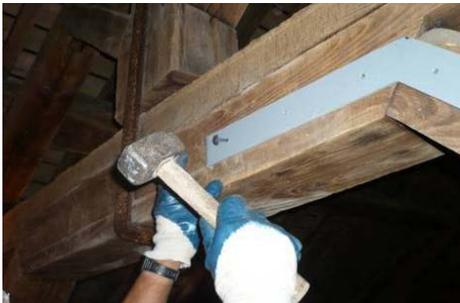
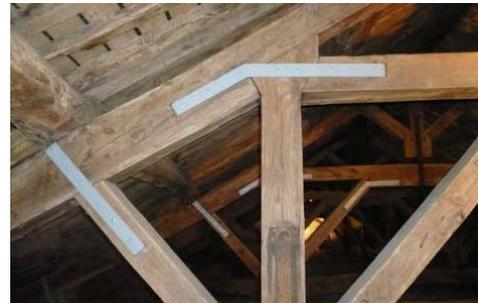
Fig. 14 – Use of traditional steel elements to improve the connection between timber elements.

The connections between the trusses elements were reinforced with steel plates, traditionally used in the construction of timber trusses, Fig. 14.

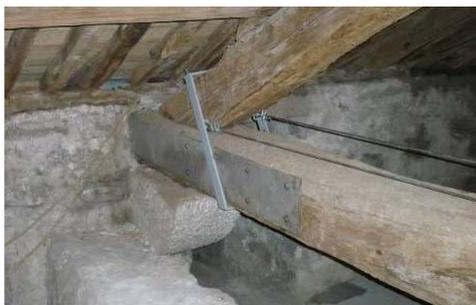
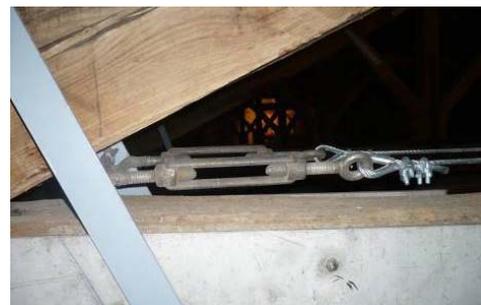
Fig. 15 – Introduction of stretched steel cables to connect rafters of trusses.

Stretched steel cables connecting the rafters of the trusses were placed to avoid the rafters to slide on the top of the tie beams. These cables act as tie-beams and contribute to the proper functioning of the trusses, Fig. 15.

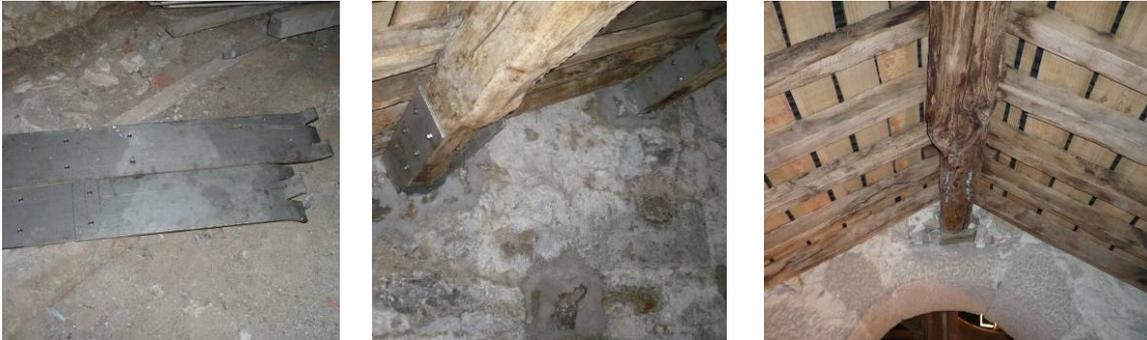
Fig. 16 – Strengthening of the supports of rafters/ridges and the masonry walls.

The connections of the rafters and ridges to the masonry walls were reinforced with steel plates and threaded rods, solution similar to the one used with the tie beams, Fig. 16.

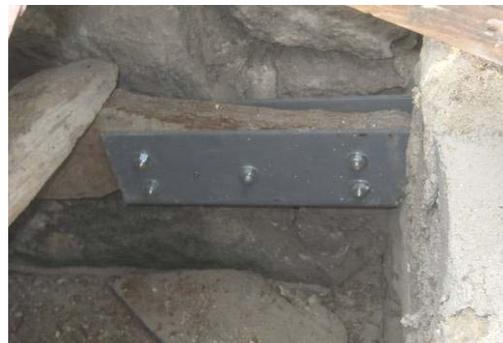
In the Upper Choir's roof it was observed the warping of some trusses tie beams and rafters and the rupture of some other structural elements. The rehabilitation of the roof involved some particularities, not linked to the direct intervention on the structural elements, but due to the constraints associated to the existence of a wooden ceiling with painted coffers connected to the trusses, Fig. 17. This ceiling, with high patrimonial value, was restored *in situ* in order to avoid its deterioration, fact that obliged the structural intervention to be developed by the upper side of the ceiling. The care needed to avoid damaging the coffers implied some additional precautions, such as the protection with geotextiles and the maintenance of temporary struts to support the ceiling.

Fig. 18 – Strengthening of the supports of ceiling beams with steel plates and threaded rods.

The intervention in the roof consisted in the strengthening of the structural elements showing insufficient transversal section, mainly in the supports, through the introduction of steel plates connected to the sides and, in some cases, to the bottom of the elements through threaded rods, and fixed to the masonry walls, Fig. 18 and Fig. 19. The connections between the support beams and the ceilings were reinforced with new timber elements, in order to avoid the ceiling to deform. In very specific situations, new timber structural elements were introduced to substitute the damaged ones, Fig. 20.

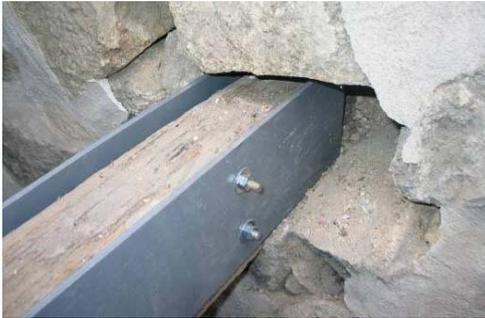
Fig. 19 – Strengthening of the supports of tie beams with steel plates and threaded rods.

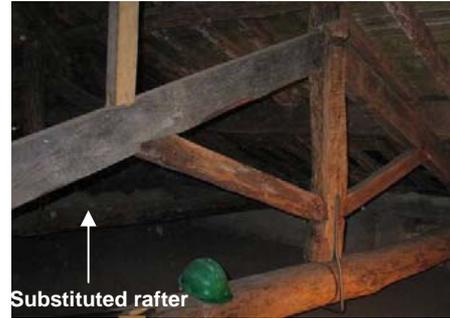
Fig. 20 – Substitution of a rafter by a new element.

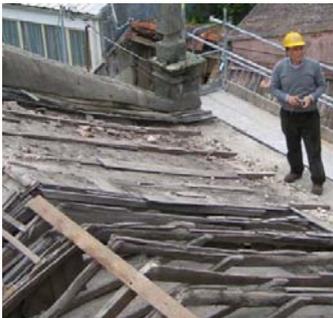
In the case of the Apse timber roof, exclusively constituted by rafters and with intense degradation, it was observed the cracking of the subjacent vaulted ceiling. As these cracks could be stabilized through an efficient bracing of the support masonry walls, it was decided to create a new and stiffer timber roof, Fig. 21 and Fig. 22. This new roof was identical to the old one, but with reinforced connections between structural elements by means of traditional carpentry joints and steel elements, Fig. 23, which contributed to an increase of the trusses stiffness and, consequently, to the improvement of the walls structural behaviour. Additionally, the connection between the rafters, and the mudsill and between this one and the walls, were reinforced to mobilize the global structural behaviour of the building.

Fig. 21 – Original roof of the Apse.

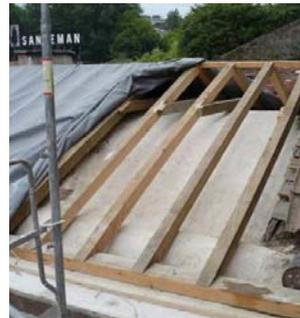
Fig. 22 – New timber roof of the Apse.

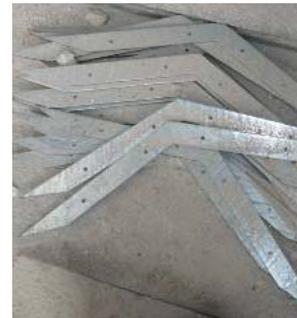
Fig. 23 – Steel elements introduced to increase the stiffness of the roof
