Sustainable interventions: Rehabilitation of old timber structures with traditional materials

Tiago Ilharco

Faculty of Engineering of Porto University

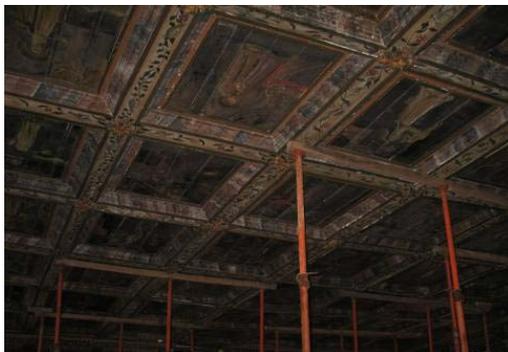
The survey performed in Corpus Christi church evidenced the intense degradation of the timber roofs (Upper Choir and Apse), as the result of biotic attacks (13).

In the Upper Choir's roof it was observed the warping of some trusses tie beams and rafters and the rupture of some other structural elements. The rehabilitation of the roof involved some particularities, not linked to the direct intervention on the structural elements, but due to the constraints associated to the existence of a wooden ceiling with painted coffers connected to the trusses, Fig. 17. This ceiling, with high patrimonial value, was restored *in situ* in order to avoid its deterioration, fact that obliged the structural intervention to be developed by the upper side of the ceiling. The care needed to avoid damaging the coffers implied some additional precautions, such as the protection with geotextiles and the maintenance of temporary struts to support the ceiling.

Fig. 17 – Existent wooden ceiling with painted coffers.

The intervention in the roof consisted in the strengthening of the structural elements showing insufficient transversal section, mainly in the supports, through the introduction of steel plates connected to the sides and, in some cases, to the bottom of the elements through threaded rods, and fixed to the masonry walls, Fig. 18 and Fig. 19. The connections between the support beams and the ceilings were reinforced with new timber elements, in order to avoid the ceiling to deform. In very specific situations, new timber structural elements were introduced to substitute the damaged ones, Fig. 20.

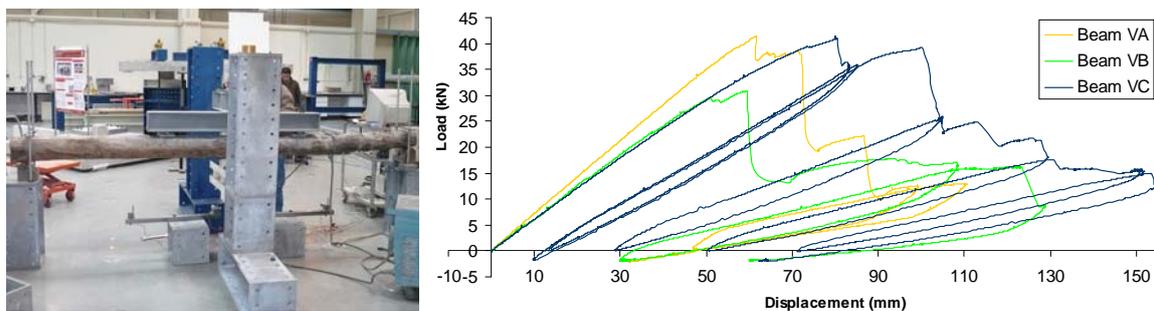
The behaviour of the original beams (first test) was linear elastic until a fragile rupture, which had place at half-span, near knots or other defects situated in the tensioned side, showing their strong effect in the structural behaviour of the timber elements, in particular in the bending strength. This rupture happened for values close to 40,0kN and for half-span displacements of 60,0mm, Fig. 24. Afterwards, the beams responded with a small “plastic plateau” until higher displacements (about 90,0mm), followed by a second sudden rupture and a gradual decrease of strength. The loading and unloading cycles were applied to the beams after the first rupture until maximum displacements of about 130,0mm. The final residual displacements were of 70,0mm. The average mechanical properties of the beams were calculated according to EC5 (11) and are in the range of expected values: modulus of elasticity, $E_{m,g} = 7,5\text{GPa}$ and bending strength, $f_m = 36,2\text{MPa}$. The result of the modulus of elasticity was close to the values obtained in an *in situ* load test performed on beams of the same timber floor (5).

Fig. 24 – Tests on timber specimens according to (2) – Setup and Load vs displacement diagrams.
